UNDERWATER BRIDGE INSPECTION REPORT

STRUCTURE NO. 4992

CSAH NO. 4

CLEARWATER RIVER (DAM)

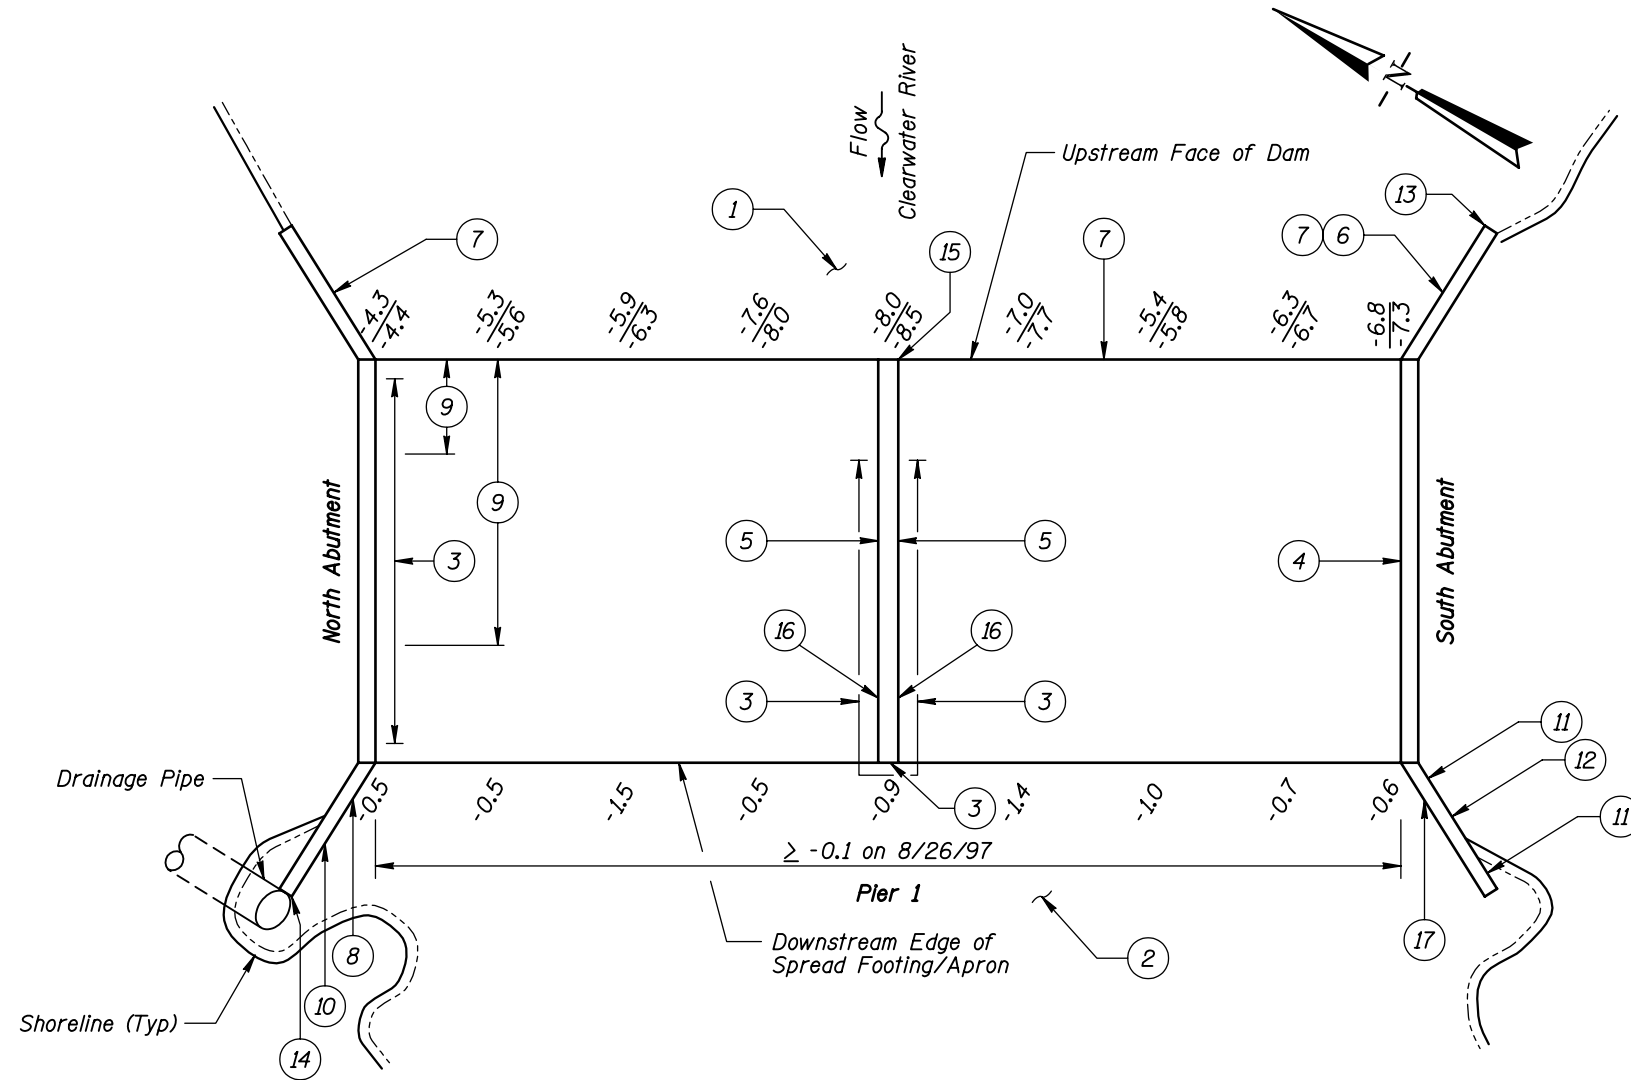
SOUNDING PLAN

- 1 The channel bottom material consisted of sandy gravel with random riprap and up to 2 inches of probe rod penetration.
- 2 The channel bottom material consisted of 6 to 18 inch diameter riprap with no probe rod penetration.

- 3 Failed concrete repair with random map cracking and exposed reinforcing steel from the waterline to 4 feet above the waterline, with 1 inch maximum penetration on the north face of the Pier, and typical 1 to 2 inches and a maximum of 4 inches of penetration on the rest of the Pier and North Abutment.

- 4 Surface delamination in the concrete repair with 1/8 inch of penetration.
- 5 Vertical 1/8 inch crack on both sides of Pier 1 extending from the failed concrete repair to the pier.

- 6 Spalled, cracked, and unsound concrete area centered at the waterline, 2 feet wide by 5 feet high, with exposed aggregate and up to 2 inches maximum penetration.

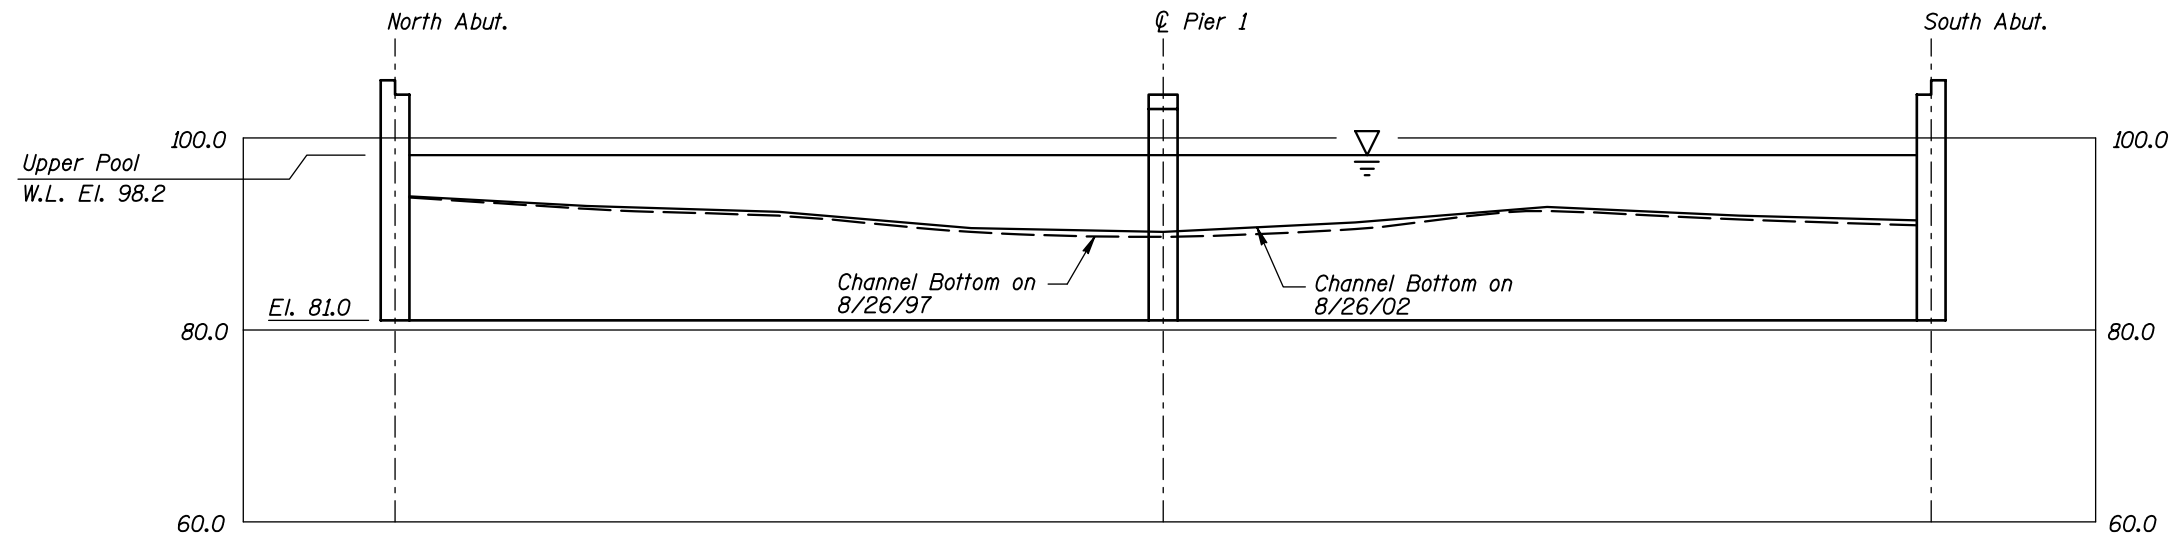
EAST FASCIA PROFILE
Vertical Scale: 1"=20'-0"

- 7 Random light concrete scaling of below water concrete surfaces with up to 1/8 inch penetration.
- 8 Vertical 1/16 inch wide crack extending from the footing slab up 8 feet through a failing repair patch with a 6 inch diameter spall 2.5 feet above the waterline.

- 9 Vertical 1/16 inch wide crack extending from the top to the bottom of the wall.
- 10 Vertical 1/16 inch wide crack extending from the top of footing slab up 8 feet through a failing repair patch with 1 foot diameter spall 2 feet above the footing.

- 11 Vertical 1/16 inch wide crack extending up from the top of footing 8 feet and continuing diagonally to the top of the wingwall.
- 12 Vertical 1/8 inch wide crack extending up from the top of footing 8 feet and continuing diagonally to the top of the wingwall.

- 13 Area of minor section loss located at the northeast corner of southeast wingwall with up to 2 inches maximum penetration.
- 14 Area of minor section loss, 6 inches wide by 6 inches high, 3 feet above the top of footing at the southwest corner of northwest wingwall.

- 15 Corner spall, 6 inches wide by 6 inches high, with 1 inch maximum penetration.
- 16 Hairline to 1/16 inch wide crack, located 4 feet from the downstream nose, extending up from the top of failed concrete repair and continuing diagonally to the downstream corner of Pier 1.

- 17 Spall, 6 inches wide by 10 inches high, with 4 inches maximum penetration.

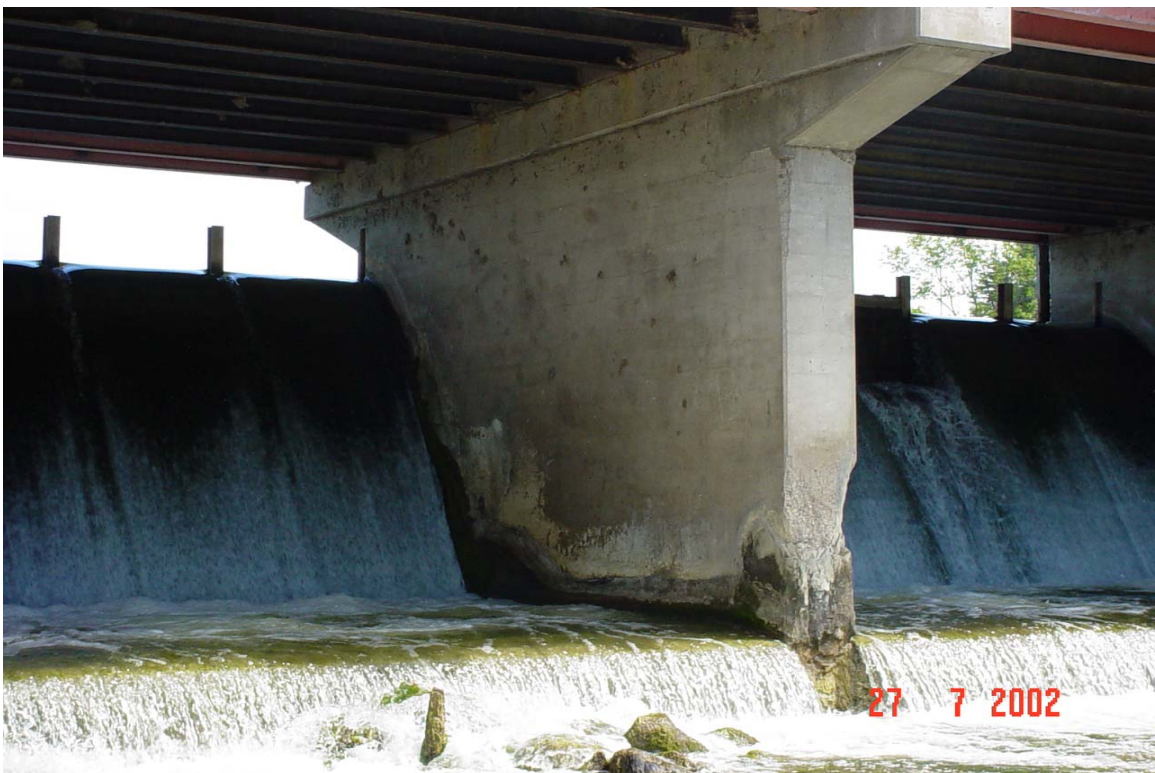
Photograph 2. View of Pier 1, Looking Southeast.

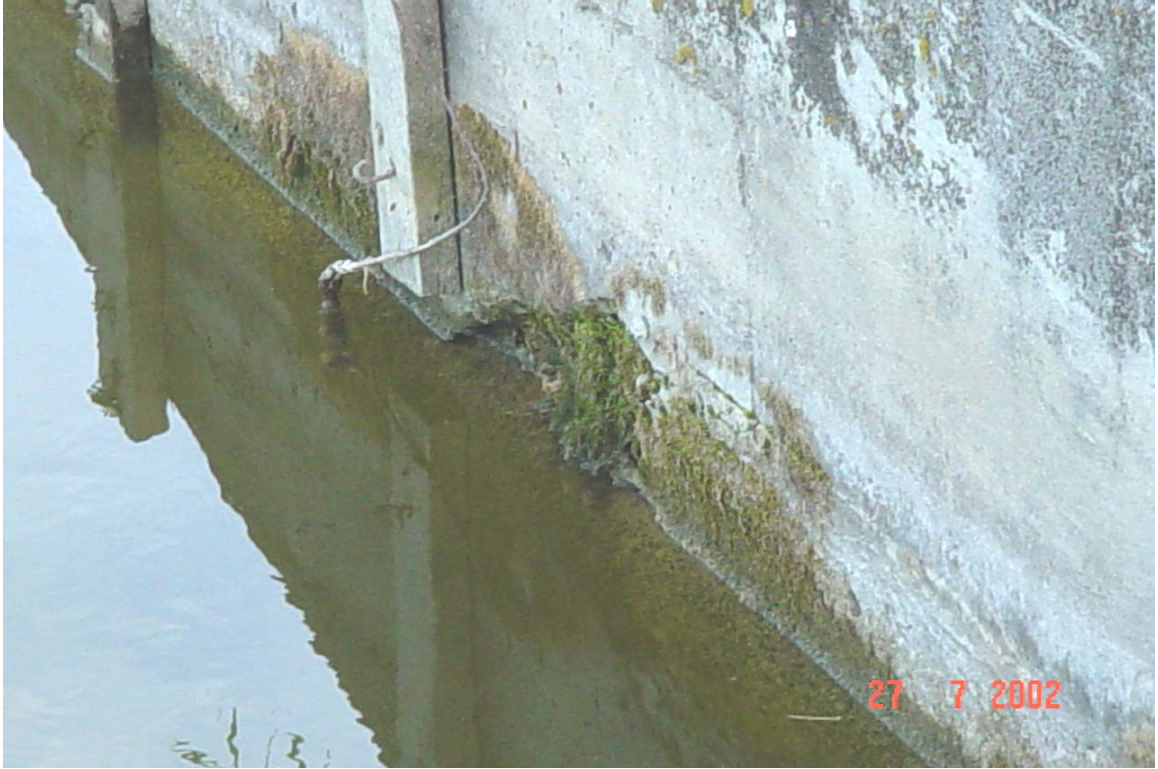
Photograph 5. View of the Spall on the East Wingwall of the South Abutment, Looking Southeast.

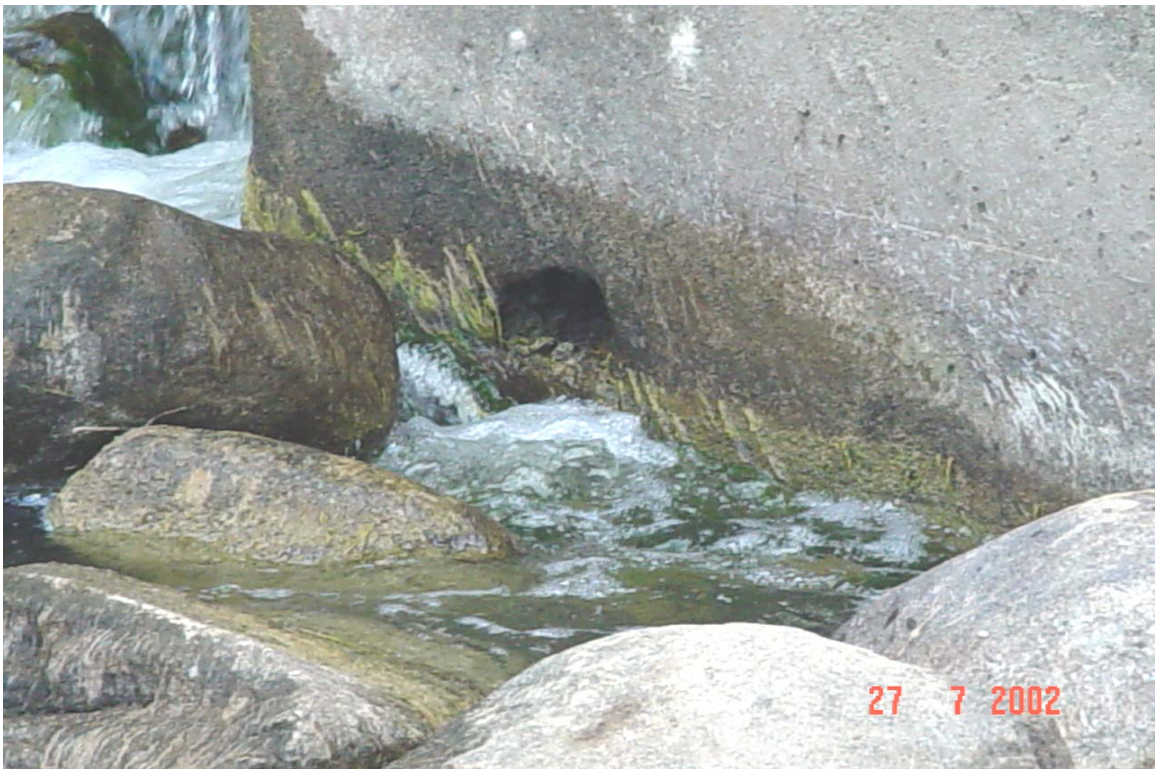
Photograph 6. View of the Spall on the West Wingwall of the South Abutment, Looking Southeast.

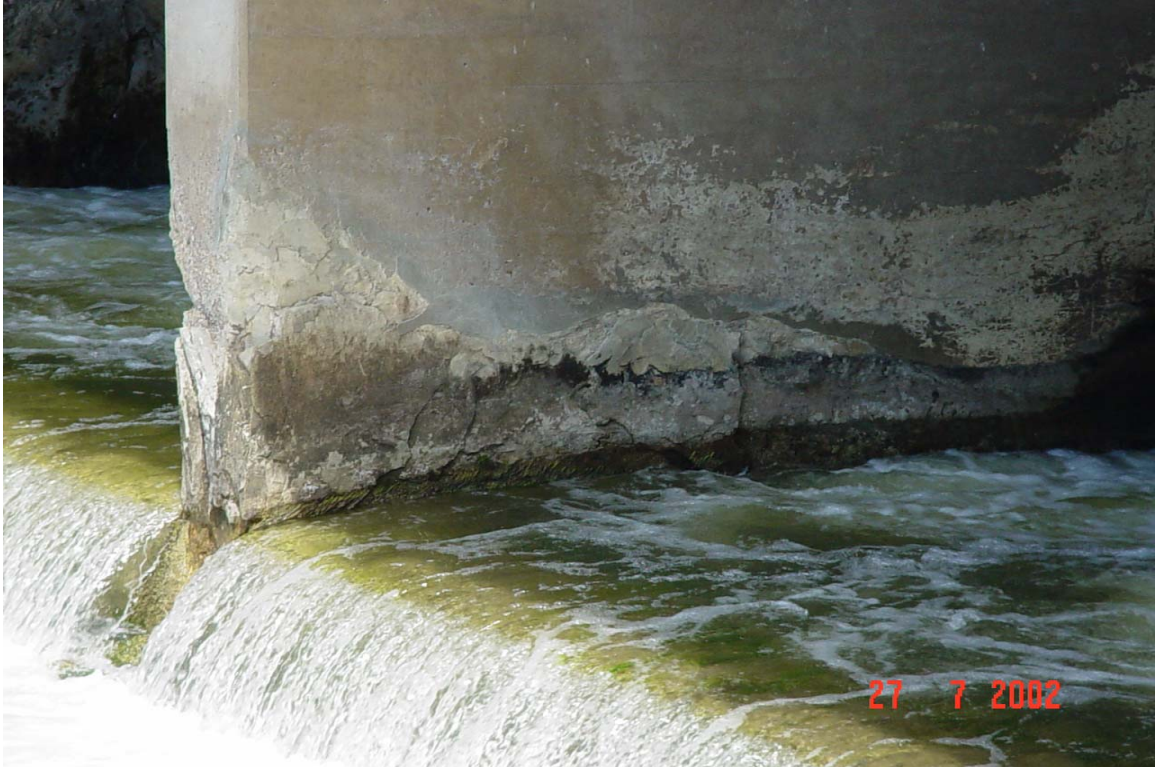
Photograph 7. View of Concrete Deterioration at the Bottom of the Center Pier, Looking North.

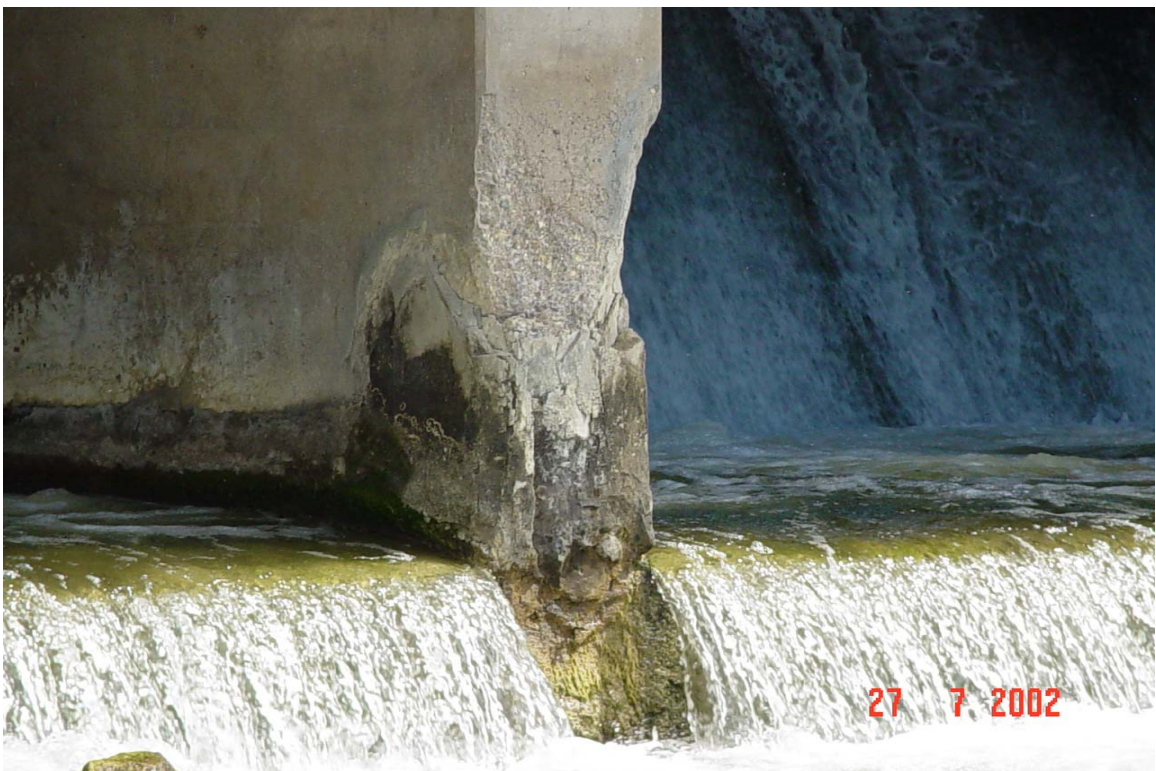
Photograph 8. View of Concrete Deterioration at the Bottom of the Center Pier, Looking East.

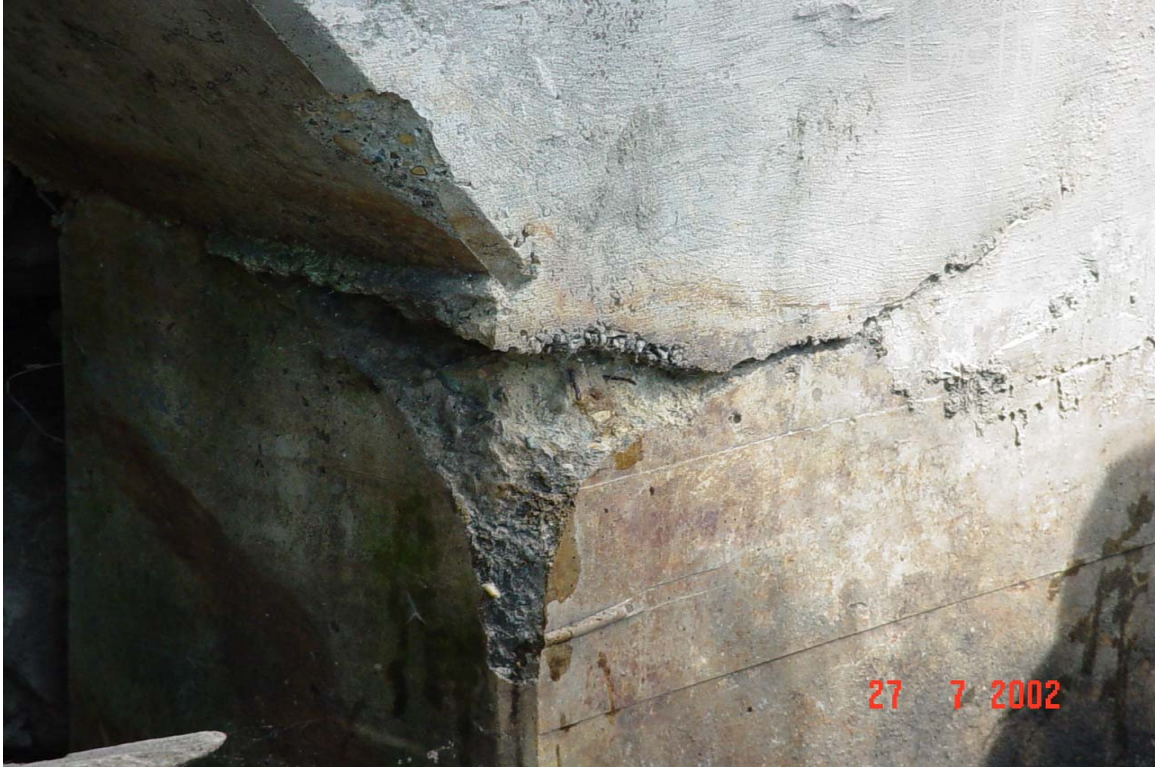
Photograph 9. View of Crack in the West Wingwall of the North Abutment, Looking North.

If long-term serviceability is desired for the structure, consideration should be given to removing all unsound concrete repair materials, and restoring the concrete surfaces by patching and recasting with a concrete mix of high durability and low permeability. In addition, the cracks on both sides of Pier 1 and in the wingwalls should be repaired by epoxy injection.

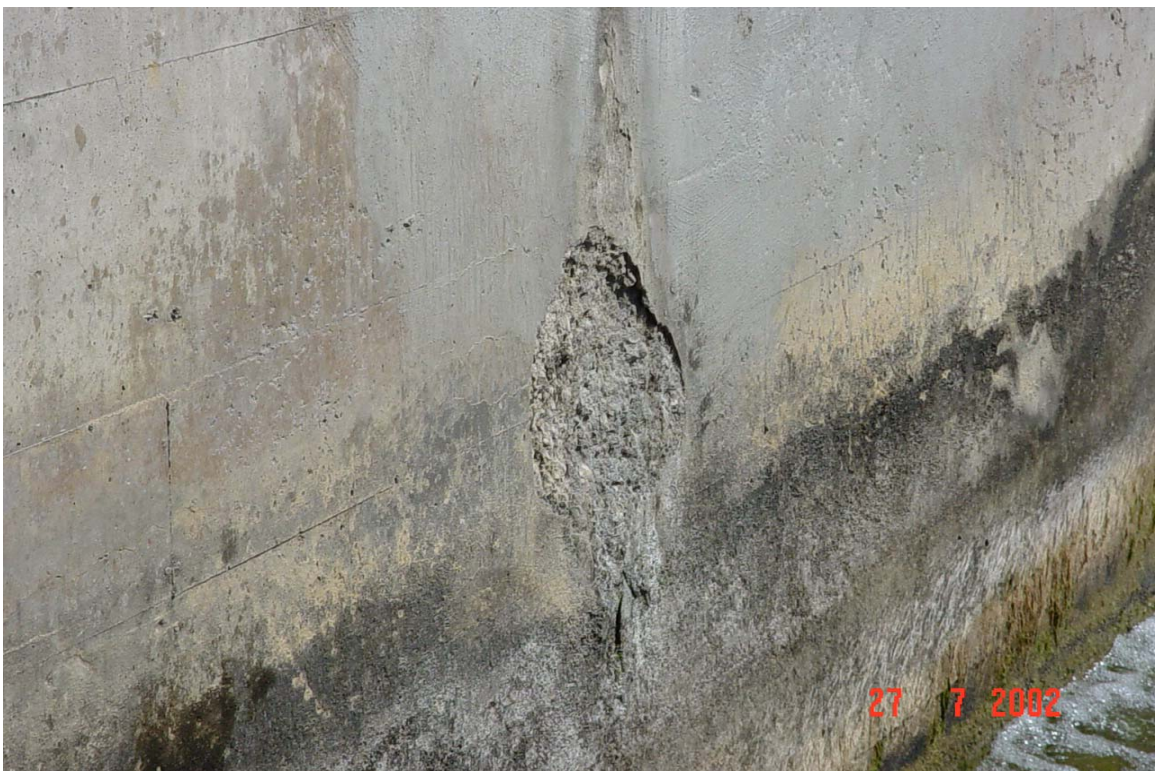
Photograph 10. View of Spall in the West Wingwall of the North Abutment, Looking North.

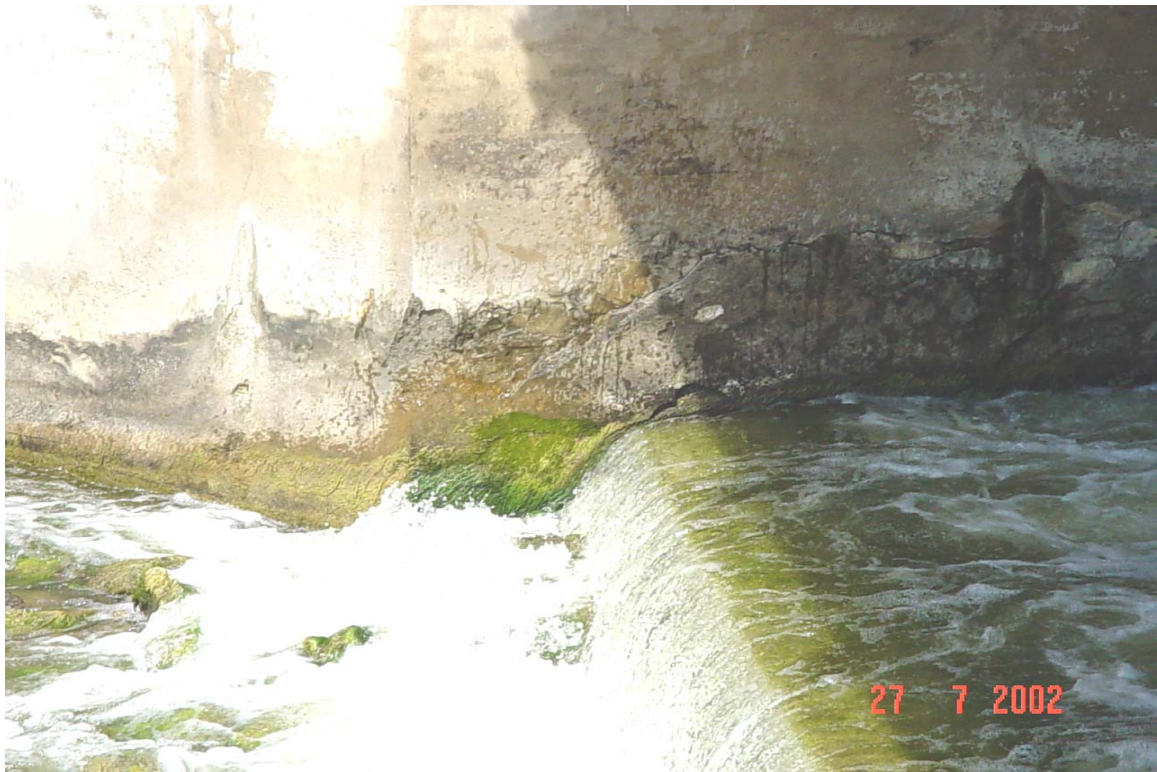
Photograph 11. View of Concrete Deterioration at the Bottom of the Northwest Wingwall and the bottom of the North Abutment, Looking North.

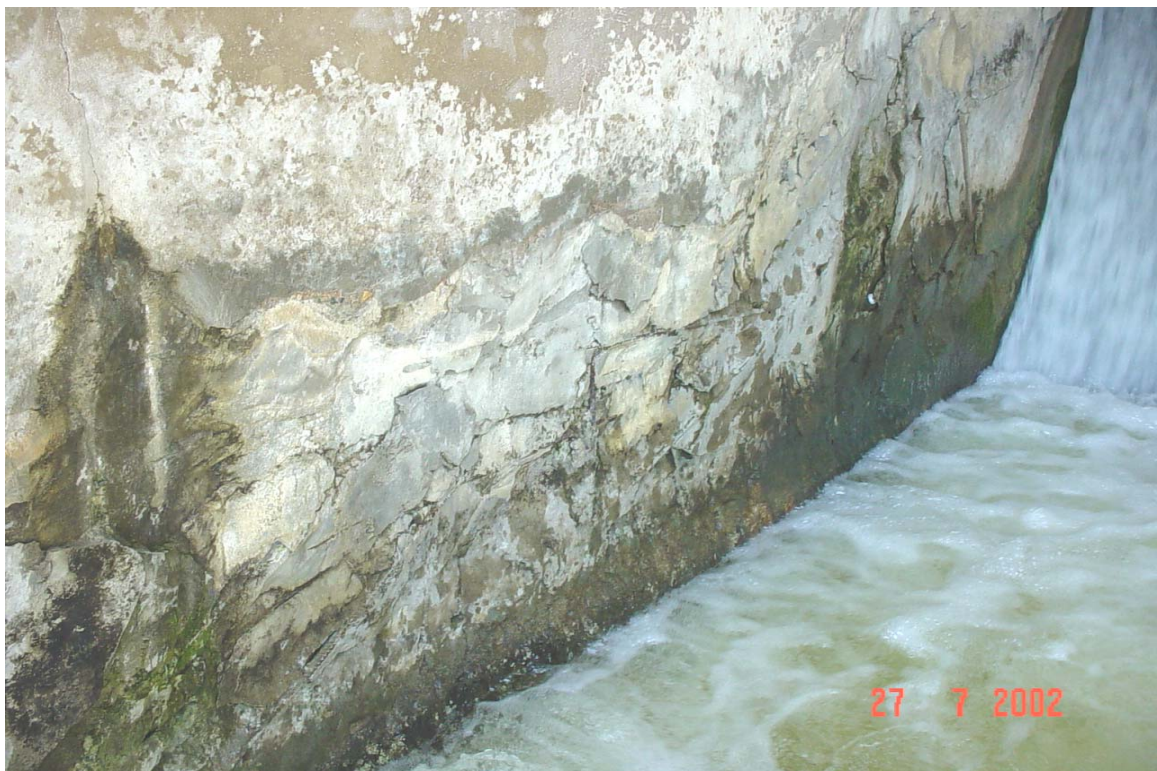
Photograph 12. View of Exposed Reinforcing Steel at the North Abutment, Looking North.
